# CRITIQUE SUMMARY

**Critique No.:** CR-C-A-2001-0005

**Date of Critique:** April 2001

**Brief Event Description:** On 4/18/01 approximately 100 gallons of UCON lubricating fluid UCON LB170X was found to have leaked from a broken fitting on a compressor pumping skid in building 1005H. Most of the fluid was contained within the skid. Some leaked out onto the floor, and a small amount (less than 5 gallons) went into the trench. The compressor shut down automatically due to interlocks at that time. However, due to residual pressure in the lines, a portion of the fluid was also atomized into the air from the small slit in the fitting, creating a fog-like atmosphere which activated the smoke detection system. The spill was reported to Fire/Rescue and spill cleanup was initiated. Based on the quantity and type of fluid (it is not petroleum based) the event was not reportable to the EPA, or NY State DEC. The spill was reported to Suffolk County SHD, BNL Director's Office, and DOE-BAO.

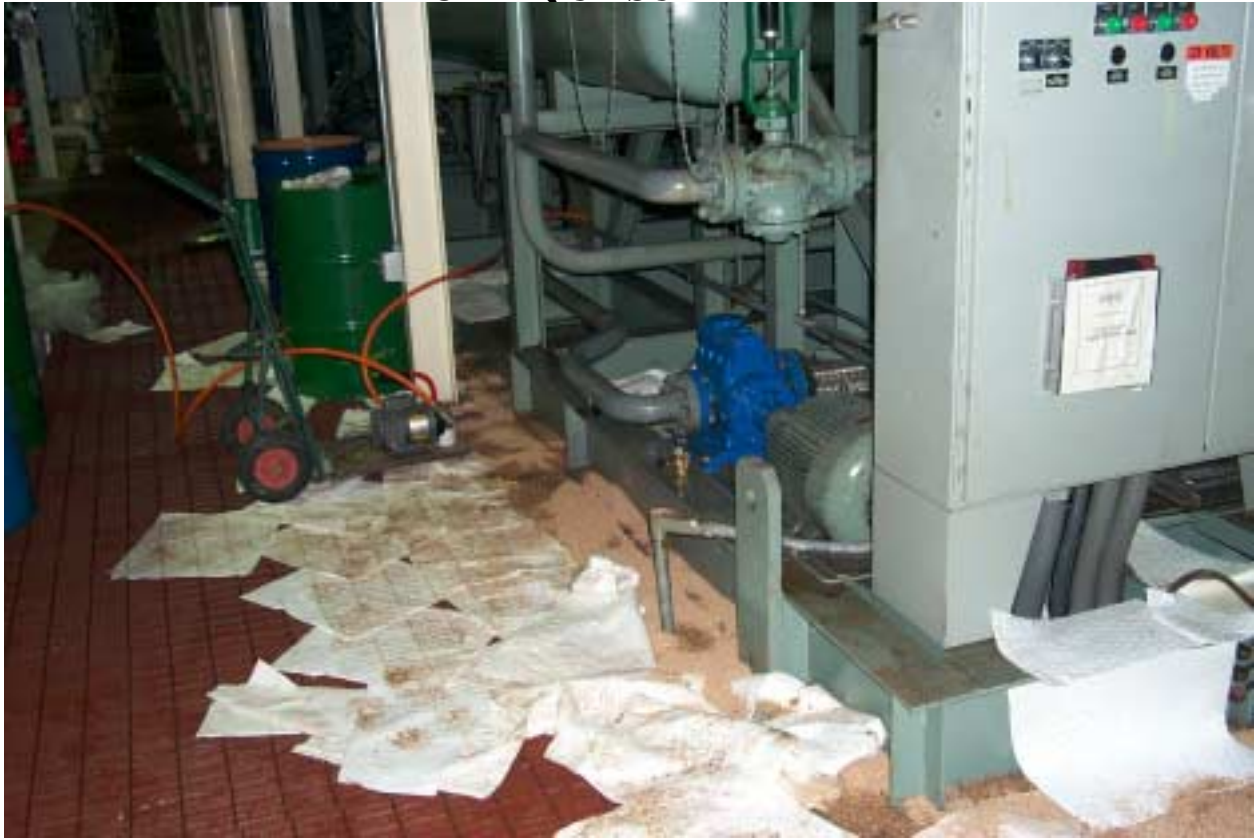
Because of the timely response of all parties, the spill was contained in the trench with spill pads and speedy-dry, and did not travel outside the boundaries of the area. The floor and adjacent equipment were cleaned up using spill pads. The fluid from inside the skid was pumped out and into drums. Approximately 75 gallons of fluid were recovered. There were also several drums of spill pads and speedy-dry. All fluid was contained inside the building and no fluid reached the environment.

**Figure 1** Location of spill in Building 1005H

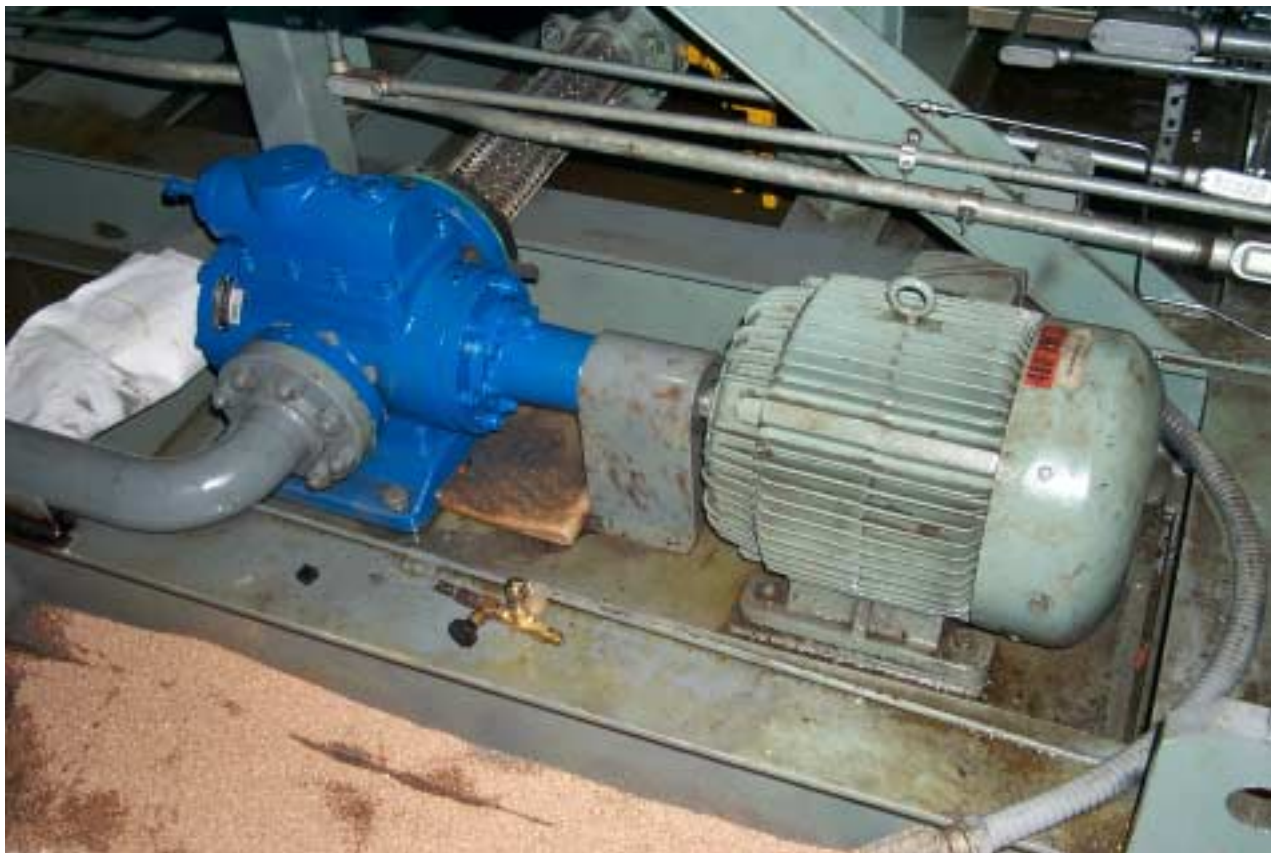
Examination of the parts revealed that a steel nipple with a brass fitting on a sample tap had eventually sheared off of the newly installed redundant compressor pump. The leak started with a small slit in the fitting, which caused the fluid to atomize. The cause of the shear is most likely due to vibration from operation of the skid, or possibly from being hit. The rubber coupling on the unit was shredded indicating vibration. The pump had not been bolted to the floor. In addition, the pump may have been out of alignment despite pre-start up vibration checks by the Cryogenic group.

1. Vibration from operation of the compressor pump caused steel fitting to shear, due to fatigue. Excess vibration may have been present because the pump had not been secured to the floor/skid.

**Figure 2** Pump with fitting removed

1. All similar fittings in the compressor building should be inspected for fatigue.
2. Investigate a possible re-design of the fittings to ensure reliability.

3. Evaluate the possible damage to the new pump, make sure windings were not affected.
4. Initiate a tool-box talk with cryogenics personnel on personal protective equipment. Disposable masks designed for use in oily atmospheres should have been used, as well as goggles to prevent skin contact with the mist.
